Case study

Perforated mechanism of a water line outlet tee pipe for an oil well drilling rig

A corroded tee pipe belonging to a 10-in new separator water line outlet installed in an offshore oil well drilling rig was investigated. The configuration of the large corroded pit had the shape of an imperfect horse's hoof with a completely corroded interior and a honeycomb-like cavity. There is a badly corroded pit at the welded seam at the joint connecting the tee pipe and flange. The material strength of the tee pipe meets the requirement of ASTM-A234 Gr. WPR, but its chemical composition does not meet the stipulated requirements. A deformed streamline structure or twin crystal in the ferrite phase can be seen near the surface or sub-surface of the perforated corrosion puncture edge. The micro-hardness is also different from that of the original material. The SEM results show that the puncture appears to have been a mode of quasi-cleavage fractures with secondary cracks along the direction of the crystal grain; thus, the failure has the features of mechanical and chemical corrosion. The corroded surface contains high amounts of O, C, and N, as well as S, Cl, Si, Na, Mg, Al, K, Ti, et

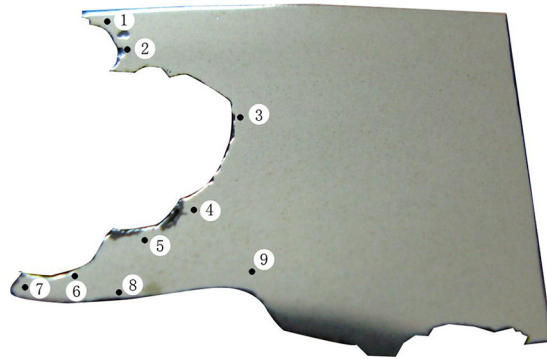
Fig. 2. Metallographic-grinding surface appearance of location A.

The specimens used for metallurgical examination are taken from locations A, B and C, as shown in Fig. 1. Location A is near the perforation and appeared to have a severely metallographically ground appearance, as shown in Fig. 2. The metallographic structure at location ⑨ is shown in Fig. 3, in which (b) is a partially enlarged image of (a); the metallographic structure is shown to primarily contain ferrite. As shown in the proportion of pearlite, the carbon content of the three-way

The metallographic structure denoted by locations ① through ⑧ in Fig. 2 is representative of the surface or sub-skin layer of the corroded cavity.

Due to the presence of surface or sub-surface deformation, deformation hardening should have occurred. The micro-hardness tests at locations ① and ② in Fig. 2 show that the hardness from the surface to the inside of the corroded cavity decreases from 163HV_{0.2} to 130–140HV_{0.2}; this shows that the hardness of the surface and sub-surface increased due to deformation hardening.

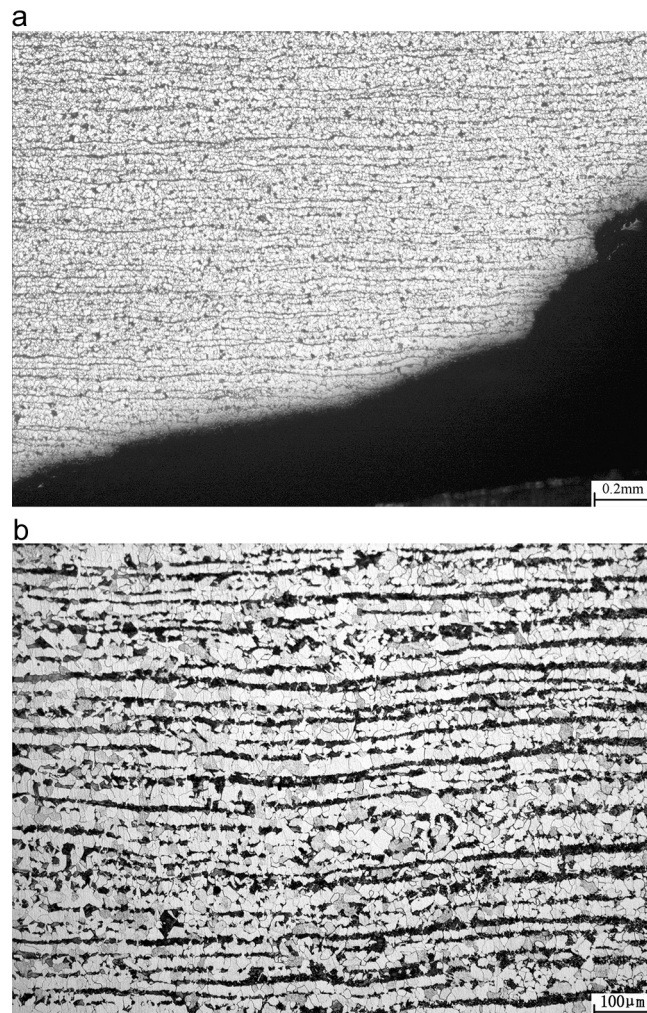
Fig. 3. Microstructure of location ⑨ in Fig. 2. (a) 50 \times ; (b) 100 \times .

pipe material is 0.15–0.20%. At low magnification, the banded pearlite structures appear parallel to one another with each appearing similar to a straight line and nearly having the same width.

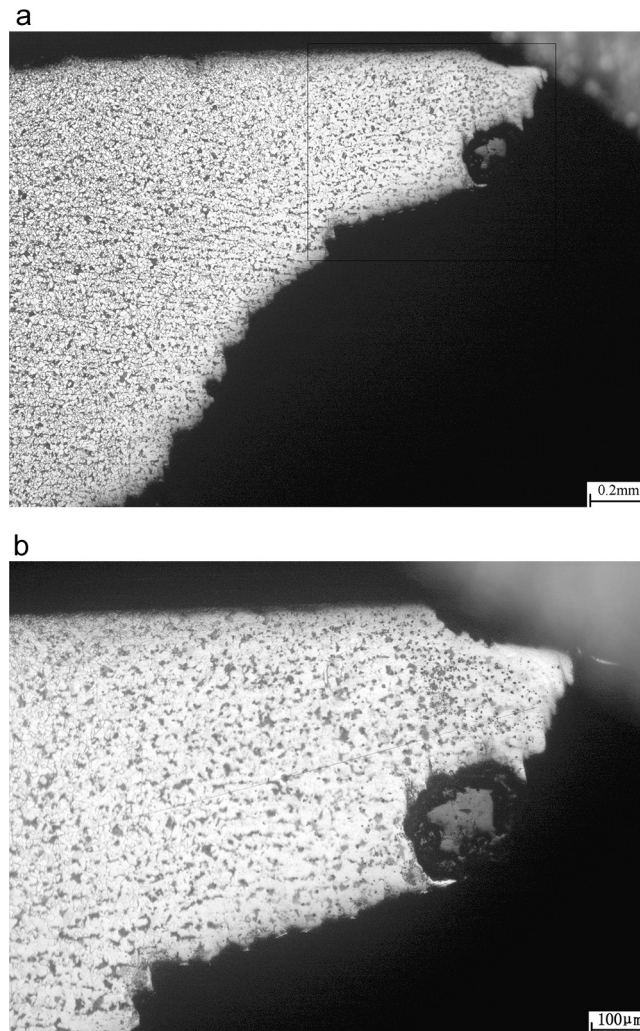
Location ① lies at the edge of the penetrating puncture and near the next external surface of the pipe (i.e., the bottom of the above-mentioned basin whose metallographic structure is shown in Fig. 4), where (b) is a partially enlarged image of (a), where a deformed streamline structure is shown. A deformed streamline structure is characterized by nearly parallel bands without external forces and deformations, as shown in Fig. 3. The distances between the pearlites are approximately equal; however, the pearlite bands are not parallel to one another and are disorganized.

A deformed streamline structure is shown near the surface or sub-surface of the corrosion-perforated hole, which indicates external forces acted on the area because general chemical corrosion and electrochemical corrosion do not cause deformed streamlines.

Fig. 4. Microstructure of location ① in Fig. 2. (a) 50 \times ; (b) 100 \times .

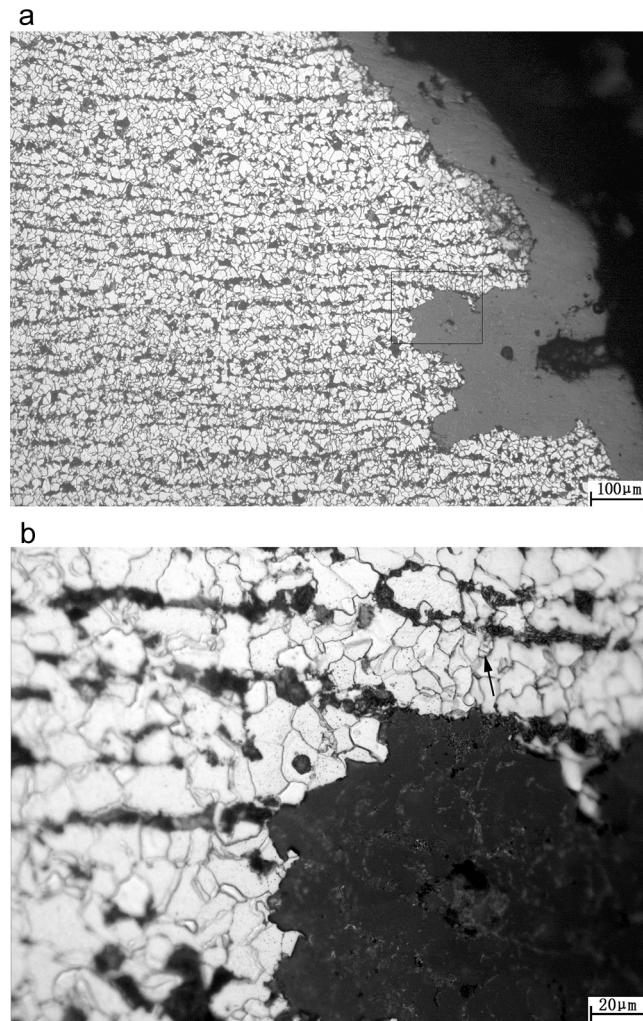
The characteristics of the metallographic structure are denoted by location ④ in Fig. 5, where (b) is a partially enlarged image of (a), and the characteristics at the edge of the corroded cavity are different from those denoted by locations ① and ②; the deformed streamline structures are not apparent, and the pearlite bands extend in parallel to the edge of the corroded cavity; also, the edge of the corroded cavity is not smooth, and the closed angles of it connect with the pearlite bands, which has the features of electrochemical corrosion. This occurred most likely because pearlite is a mixed two-phase structure that is easily corroded; also, although deformed streamline structures are not present, thin strips in the twin crystal can be observed in the ferrite phase, as indicated by the arrow in (b) [13]. These thin strips in the twin crystal have been observed on the other edge area as well. It is believed that the twin crystals formed due to deformation [14–18].

Fig. 5. Microstructure at location ④ in Fig. 2. (a) 50 \times ; (b) 100 \times .

It is shown in Fig. 5 that corrosion began as electrochemical corrosion of the pearlite and then continued as external corrosion with applied force, as indicated by the presence of the twin crystals. If a large trench is first formed by alternative electrochemical corrosion, ferrite is separated into a “peninsula”. When there is bubble burst, impact waves are typically generated, causing this “peninsula” to detach or simply further corrode electrochemically, isolating this “peninsula” and eventually causing it to break off.

Fig. 5 also shows that the primary form of corrosion was electrochemical.

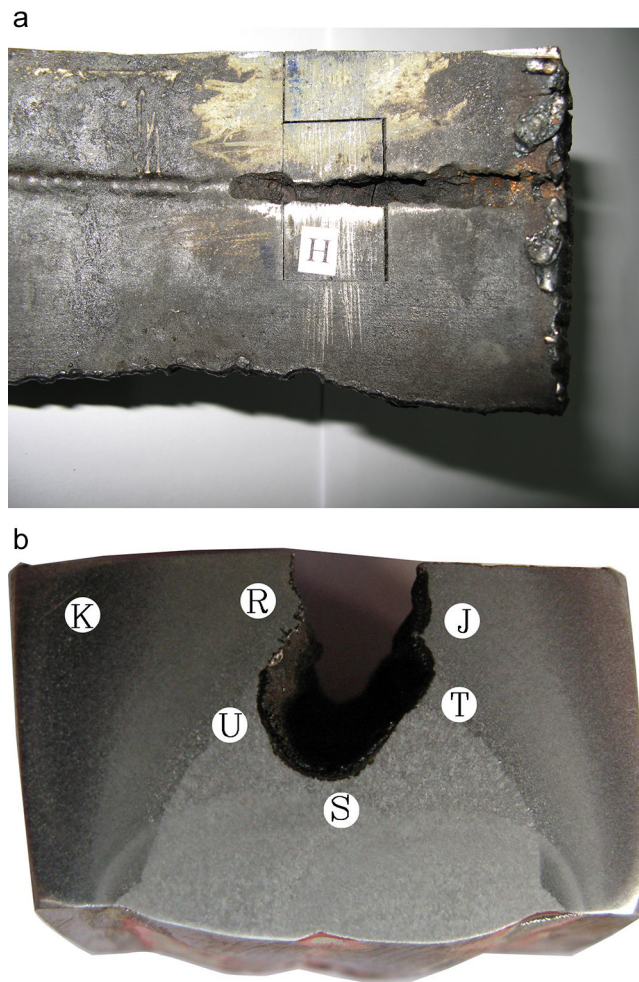
Fig. 6. Appearance of the corroded cavity of the welded seam. (a) pattern of the corroded cavity; (b) appearance of the cavity after metallographic grinding.

It can be seen from Fig. 6 that the welded seam is seriously corroded along its length and depth. Fig. 6(b) clearly shows the heat-affected area and basin appearance, which is shaped like a triangle. The area indicated by symbols (R), (U), (S), (T) and (J) is the corroded cavity in the range of the corroded basin.

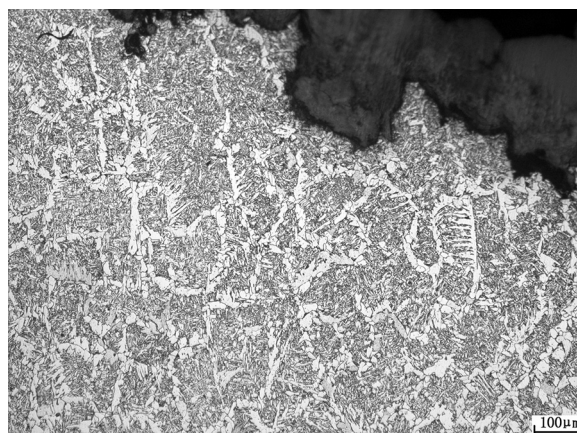
Fig. 7 shows the metallographic structure of the molten pool of the welded seam, which is relatively complex and appears to have been caused by alternative electrochemical corrosion with features inside the columnar crystal that were corroded

Fig. 7. Metallographic structure of the molten pool in the weld on the internal surface of the tee pipe.

first followed by its boundary. The columnar crystal is a multi-phase structure that can be rapidly corroded, while the boundary of the crystal is a single-phase ferrite, which is a feather-like carbon-free upper bainite, which corrodes slowly.

The front end (i.e., edge) of the corroded cavity shows that the corrosion extends in the direction of the columnar crystal; thus, the molten pool, whose front end is located at (S), is corroded more rapidly than locations (R) and (J), and eventually forms a deep trench along the welded seam.

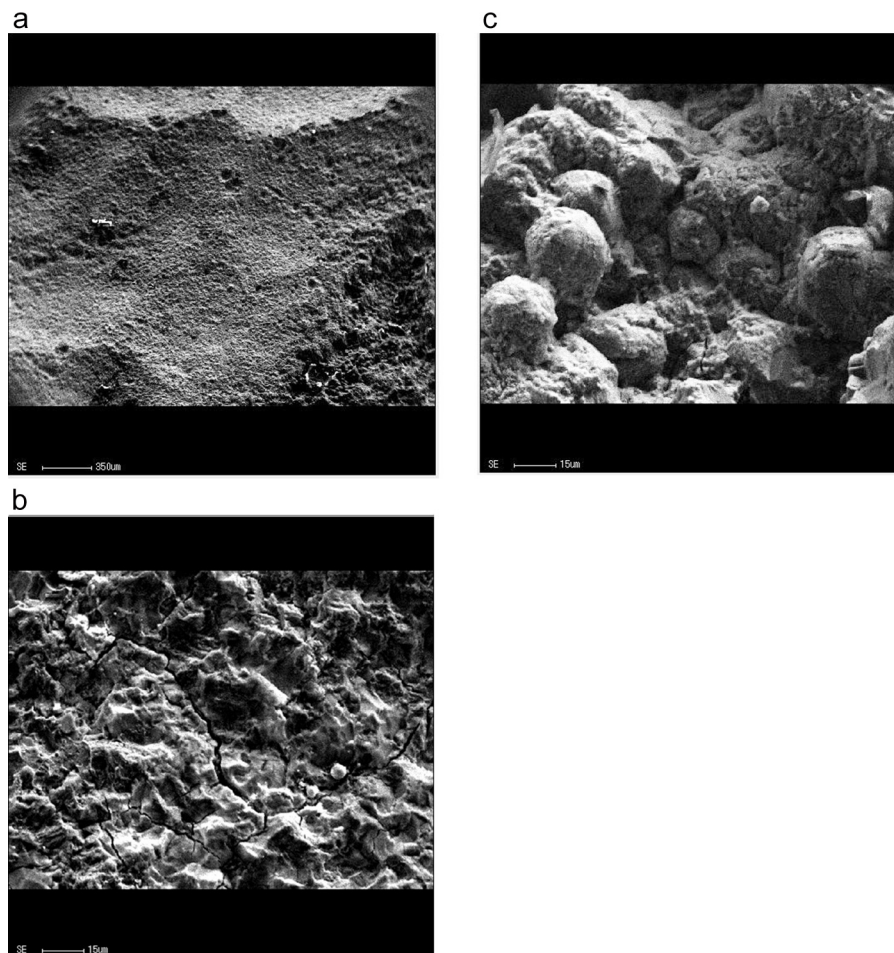
Location “B” in Fig. 8 shows an electronic microimage obtained via secondary electron observation. It is seen from Fig. 8(a) that the surface of the corroded cavity appears similar to the beach marks formed by the regular arrangement of small pits. The range of the corroded cavity is divided into several areas, whose small pits are consistent in their arrangement directions. However, the arrangement directions of the small pits in different areas vary; certain areas appear like “farmland,” as shown in Fig. 1(b) and (c), while the boundary between two areas appear like “ridges.”

The image shown in Fig. 8(b) shows features that can only be caused by mechanical actions with the fracture mode similar to those of quasi-cleavage fractures. As mentioned above, the corrosion caused by bubbles breaking and from the scour of the turbulent flow is the result of material peeling off layer by layer. Whenever a layer peels off, new fractures begin, leading to secondary cracks that can be clearly seen along the direction of the crystals. Metallographic inspection of the axial ground

Fig. 8. Electronic micro-image of location “B”. (a) Surface of the corroded cavity; (b) amplified image of the corroded cavity; and (c) amplified image of the corroded cavity in another area.

surface of the pipe ruled out the possibility of intercrystalline corrosion. It is quite certain that the cracks along the direction of the crystals were caused by the process of layers peeling off and thus mechanical action.

The image shown in Fig. 8(c) reveals the cellular structure, secondary cracks along the direction of crystals and the features of the chemical corrosion observed.

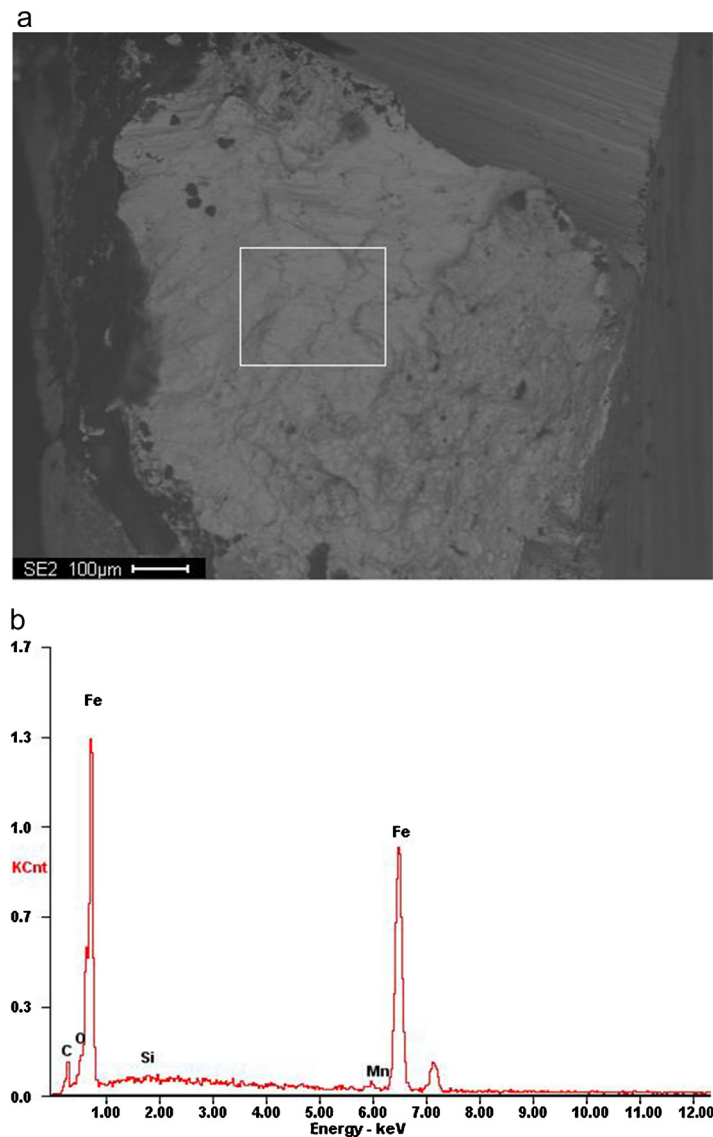
To confirm the chemical compositions of the materials of the corroded area on the surface of the inner wall of the tee pipe, X-ray energy-spectrum microinspection of chemical compositions was performed. Location “A” in Fig. 1(c) shows the inspected area near to the penetrating puncture. The tested results show that the corroded surface contains large concentrations of oxygen, carbon, and nitrogen with smaller concentrations of sulfur, chlorine, silicon, sodium, magnesium, aluminum, potassium, titanium, etc., all of which are corrosion products caused by sea water.

The spectrum bands of the chemical compositions of materials at location “A” are shown in Fig. 9.

Fig. 9. X-ray energy spectrum on the surface at location “A”. (a) analysis region; and (b) spectrum line of chemical compositions in the micro-regions.
